TECHNICAL REPORT REMR-CO-3

CASE HISTORIES OF CORPS BREAKWATER  
AND JETTY STRUCTURES

Report 5

NORTH ATLANTIC DIVISION

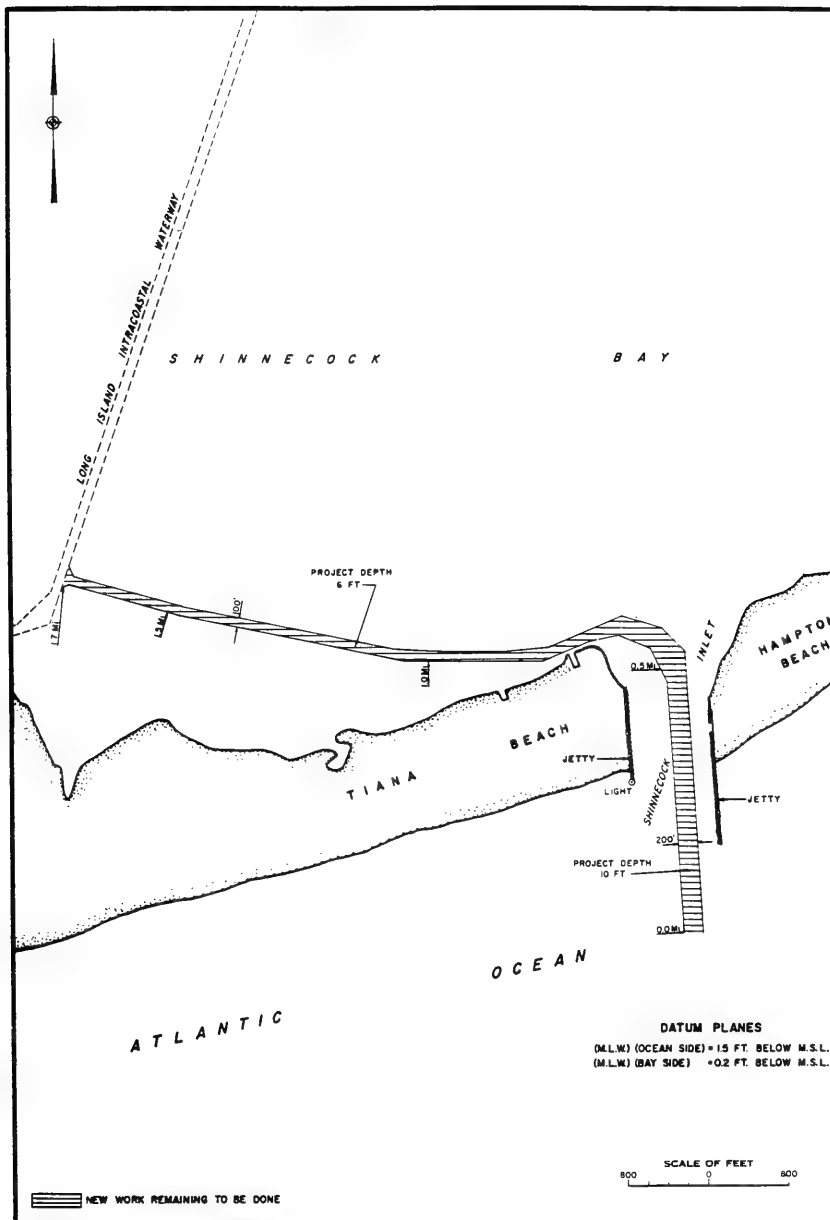
Figure 17. Shinnecock Inlet, New York

1956	A survey revealed that the east jetty had suffered severe damage. Capstones and slope stones had slipped and were disarranged in numerous spots. Core stones were washed out in several places. Capstones and core stones were washed out in four locations totaling 150 ft. The outer 250 ft of the jetty was partly washed out. Beach and dunes adjacent to the jetty eroded, and waves rode over the dunes and flanked the jetty. The west jetty was in fair condition with minor slips and disarrangement in five spots. The inlet was in a shoal condition. Most of the damage was due to a hurricane in 1954.
1982	The west jetty was reconstructed by resetting cap stones to original design geometry over 170 ft. A 1,470-ft-long pile crib revetment on the north end of the west jetty was replaced by a rubble-mound jetty. (Figure 18).
1985	A survey revealed that the reconstructed portion of the west jetty was in good condition. The seaward 200 ft of the west jetty had unraveled and capstones were scattered. The west jetty head had not maintained design configuration. Stones on the inlet side of the east jetty had sloughed in some sections, but stones on the beach side had retained their original position. Two areas on the northern end were completely deteriorated. Erosion of sand caused undermining of the east jetty with continual loss of sand undermining it further.

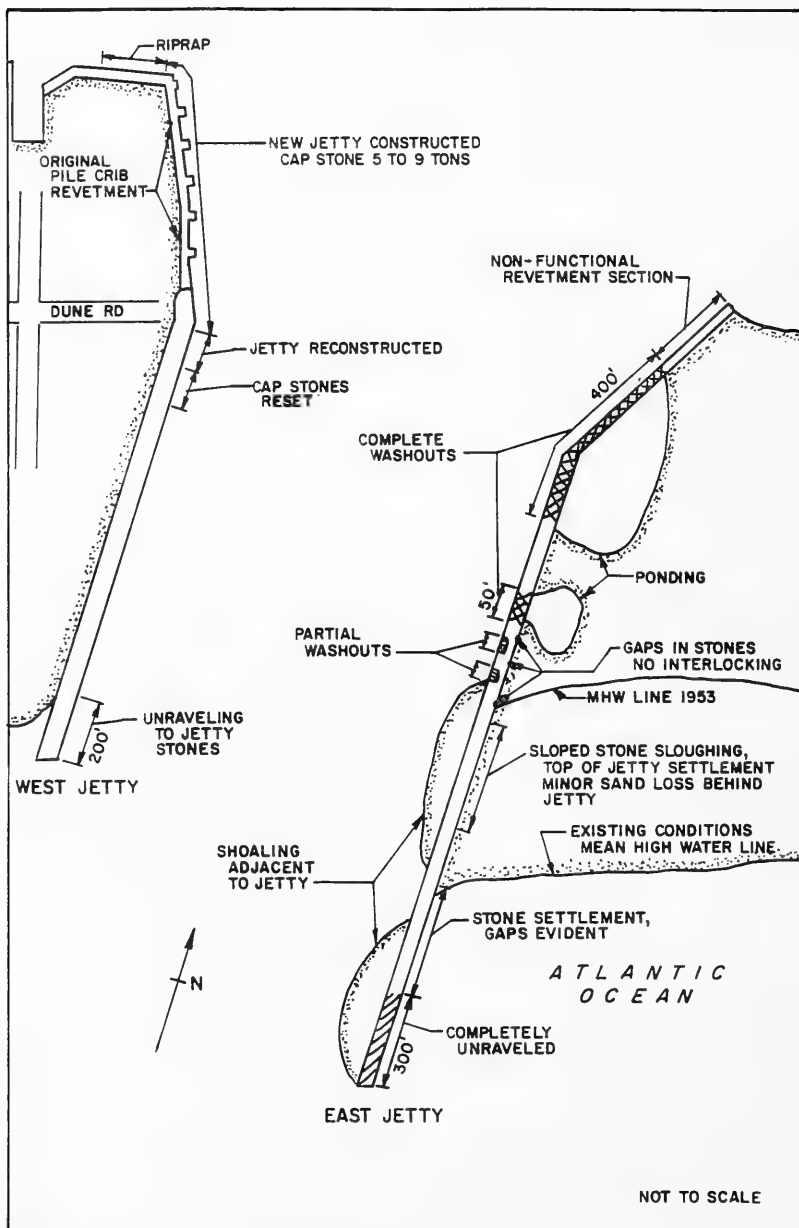
Figure 18. 1982 reconstruction of west jetty and 1985 existing conditions of east jetty, Shinnecock Inlet

Date(s)	Construction and Rehabilitation History
1985 (Cont.)	There were areas of partial washouts of stone, settlement, and non-interlocking capstones. The seaward 300 ft was completely unraveled, with all stones scattered (Figure 18). It was determined that the jetties had served their function of inlet stabilization and they were not leaking significant amounts of sand.
1986	Plans call for rehabilitation of the jetties. The east jetty will need new capstones and core stones where there are complete washouts, approximately 450 ft. Original stones will be removed and reset where settlement and sloughing has occurred, approximately 700 ft. The 300-ft east jetty head section will be completely rebuilt with new and original stone. A blanket will be placed for scour protection. A 5.0-ft-thick blanket using 1,000-lb stone will be laid on the existing bottom to prevent additional scouring of the west jetty toe. New capstone and core stone are needed to supplement the displaced stones of the west jetty head. The section will be rebuilt using existing stone but will consist of two layers of armor stone.

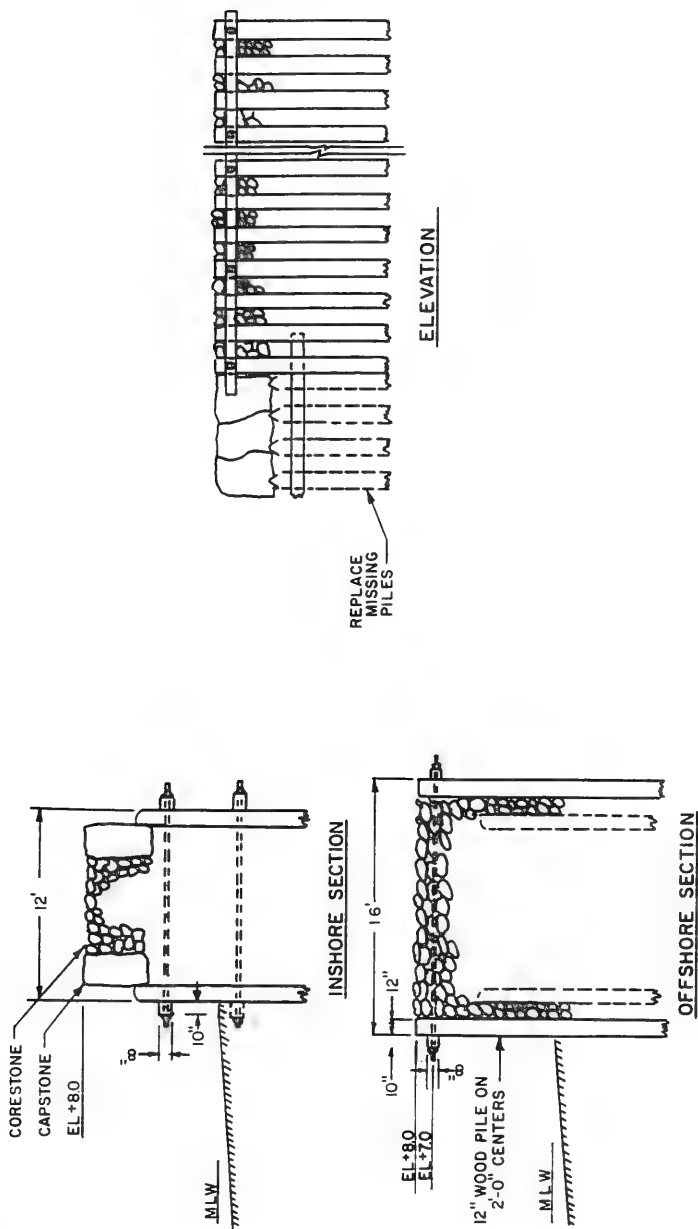
Figure 29. Rehabilitation of Mantua Creek jetties, 1963

<u>Date(s)</u>	<u>Construction and Rehabilitation History</u>
1907	Two jetties were constructed to provide channel protection. Lengths were 754 ft and 580 ft east and west, respectively. The jetties were constructed of stone-filled timber cribs, with mat brush placed to support the stone (Figure 28). Top width and elevation were 12.0 ft and +8.0 ft mlw, respectively, for each jetty.
1912-1913	The east jetty was extended to 1,577 ft, and the west jetty was extended to 1,456 ft (Figure 28).
1918	Repairs were made by the addition of stone.
1962	An investigation of the jetties revealed the jetties had settled an average of 2.0 ft. Approximately 100 ft of the offshore end of the east jetty had deteriorated, with most of the pilings gone, and stone had fallen out to below the waterline. Most of the walings had deteriorated and were missing. Piles were missing at intermediate locations along the jetties, but there was no significant loss of stone at those locations. Piles that remained were in good condition.

1963	The jetties were rehabilitated at a cost of \$136,895. A new row of piles was placed over approximately 100 ft at the offshore ends. Piles were placed 7.5 ft on either side of the center line of the jetties. Corestone was dumped between the piles to an elevation of +8.0 ft mlw (Figure 29). Missing piles were replaced, and new wales were provided along the remainder of the jetties. One row of capstone was placed on the inner sides of both cribs on top of the existing stone to +8.0 ft mlw. Core stone was filled between the capstones in the center of the jetties to +8.0 ft mlw (Figure 29). Crown width was 16.0 ft at the offshore ends and 12.0 ft on the remainder of the jetty. Design wave height was 4.2 ft.
1964	Repairs were made to the seaward end of the east jetty at a cost of \$4,864. The Corps was reimbursed later for this work.
1986	No further repair or maintenance information has been found.

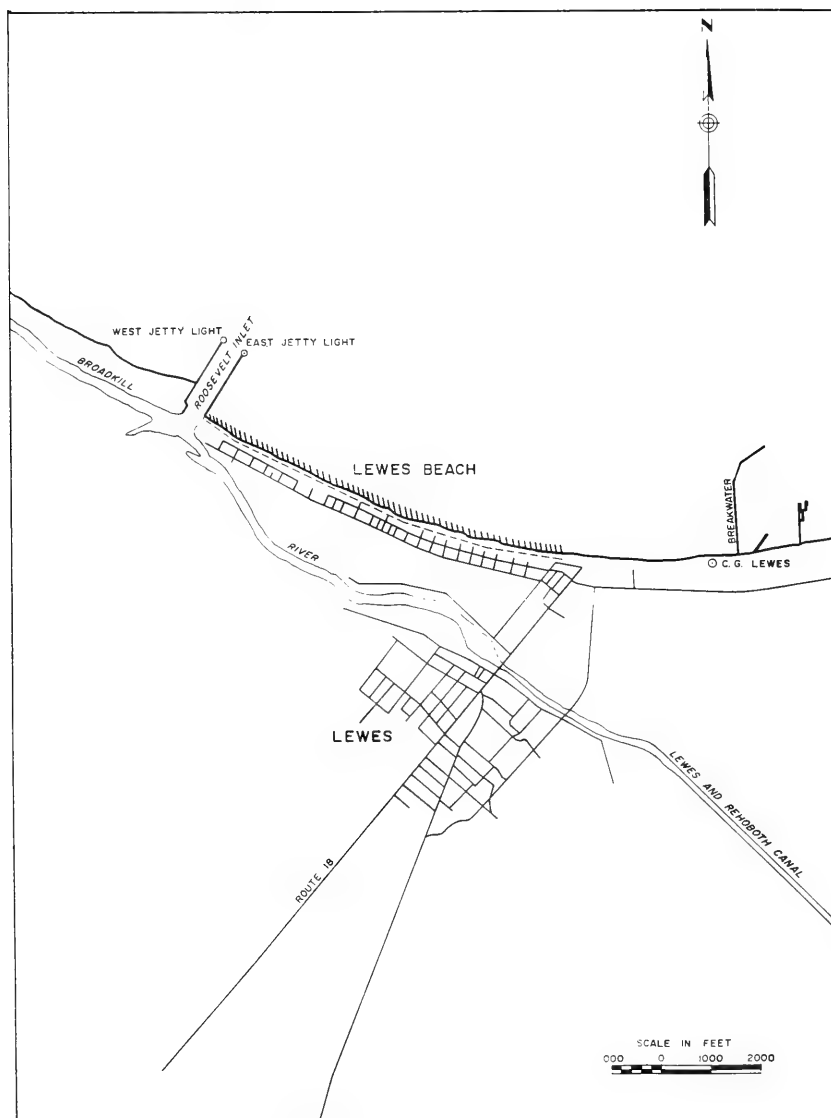
Figure 36. Roosevelt Inlet, Delaware

1985	The jetties are in poor condition and are ineffective. They are considered a navigation hazard and are to be removed.

Date(s)	Construction and Rehabilitation History
1908	A 1,263-ft-long stone-filled timber crib jetty was constructed on the west side of the inlet.
1911- 1914 1917, 1920, 1923	Stone replacement repairs were made each of these years. Cause of damage was due to inadequate jetty design; waves easily damaged the timber cribs. The cribs were also permeable to sand.
1937	The timber crib jetty was replaced by two steel sheet-pile jetties, constructed 500 ft apart, on the east and west sides of the inlet. Both jetties were 1,700 ft long (Figure 36). Crest elevations were +8.0 ft mlw, except the shoreward ends which were +10.0 ft mlw.
1939	The jetties had deteriorated due to corrosion.
1944	The jetties were flanked and rubble was placed along the east bank. The additional rubble extended the east jetty shoreward 400 ft. The possibility of the west jetty becoming completely flanked was determined to be remote; therefore, no rubble was placed on the west bank. Seaward ends of both jetties were repaired due to deterioration by corrosion.

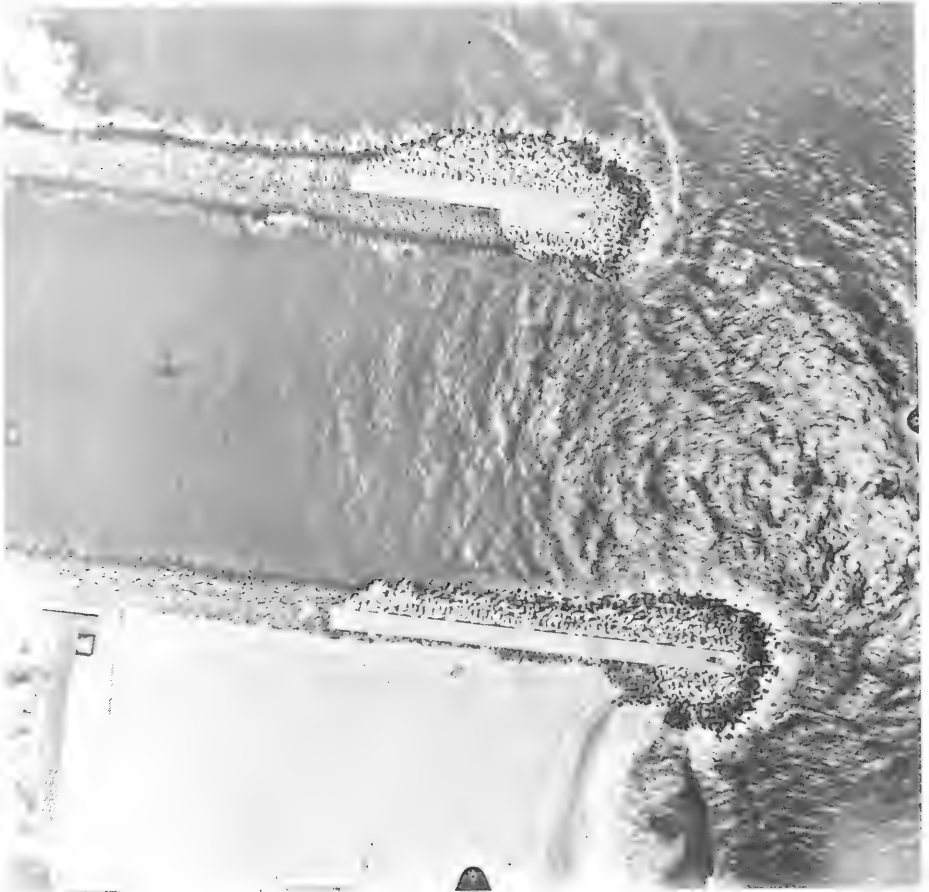
Figure 39. Photograph of Manasquan Inlet jetties  
after 1982 rehabilitation

Date(s)	Construction and Rehabilitation History
1979- 1982 (Cont.)	the south side. The seaward 240 ft was concrete capped, 35 ft wide at the seaward end and 20 ft wide elsewhere. Capstone was placed shoreward of the dolosse section, 375 ft on the north side and crest, and 90 ft on the south side. Capstone size decreased in the shoreward direction from 12.0 to 3.0 to 5.0 tons. Design wave height was 25.0 ft. An aerial photograph of the rehabilitation is shown in Figure 39.
1985	The jetties were subjected to several storms after the 1982 rehabilitation, including a design level storm in March 1984. Photogrammetric monitoring of the structures under the Monitoring of Completed Coastal Projects (MCCP) Program indicated the last rehabilitation of the jetties has been fully successful to date.

1955	The north jetty was rehabilitated using 5,400 tons of stone at a cost of \$128,597.
1959	The south jetty was rehabilitated using 12.0-ton capstone at a cost of \$67,048.
1977	The seaward 100 ft and 60 ft of the north and south jetties, respectively, were destroyed through continued displacement of armor stone and loss of structural integrity. The south jetty was damaged from the seaward end to 700 ft shoreward. Sand passed from the south jetty fillet through and over the jetty into the inlet.
1979- 1982	Both jetties were rehabilitated using dolosse. Sand and displaced stone were excavated and reshaped to design configuration before dolosse placement. Sixteen-ton dolosse were placed along the seaward 400 ft on the north side of the south jetty, around the jetty head, and along the seaward 50 ft on the south side. The dolosse extended to -10 ft mlw on the channel side, with side slopes of 1V:2H, and front slopes of 1V:3H. The seaward 400 ft was concrete capped, 20 ft wide, and was built at an elevation of +14 ft mlw. Sixteen-ton dolosse were placed along the seaward 250 ft on the north side of the north jetty, around the jetty head, and along the seaward 90 ft on
